Manhole Inspection Summary

Manhole # S21K__002MH

Insp Date: **4/2/08 3:14 PM**

Location Address: **1847 wilhelm-mchenry alley**

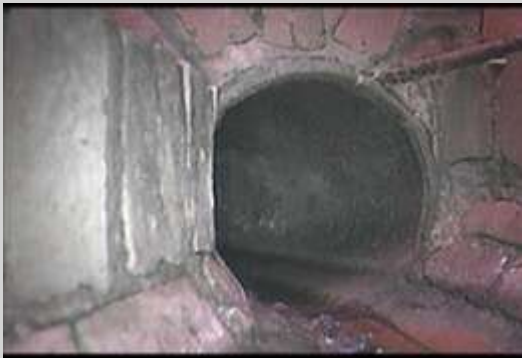
12 O'Clock Outflow

8 in. Circular Gravity Sewer
Pipe Out @ 12 O'Clock

Pipe Height: **8.4** (in.) Rod and Bar (Angled)
Pipe Material: **Clay** ☐ Pipe Lined
Invert Depth: **6.91** (ft.) Flow Characteristics: **Slow**
Deposits: ☒ None ☐ Mud ☐ Sludge ☐ Debris ☐ Grease
Silt Depth: **0** (in.) Deposits Extent:
Infiltration: **None** Pipe Seal Cond: **Sound**

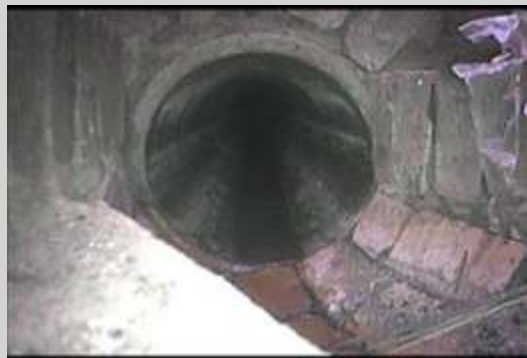
9 O'Clock Inflow

8 in. Circular Gravity Sewer

Pipe In @ 9 O'Clock

Pipe Height: **7.2** (in.) Rod and Bar (Angled)

Pipe Material: **Clay** ☐ Pipe Lined

Infiltration: **None** Pipe Seal Cond: **Sound**
